A geological assessment of the landslides in the Ironbridge Gorge, Shropshire

Prepared for Wardell Armstrong LLP
by the British Geological Survey

Commissioned Report CR/08/157N

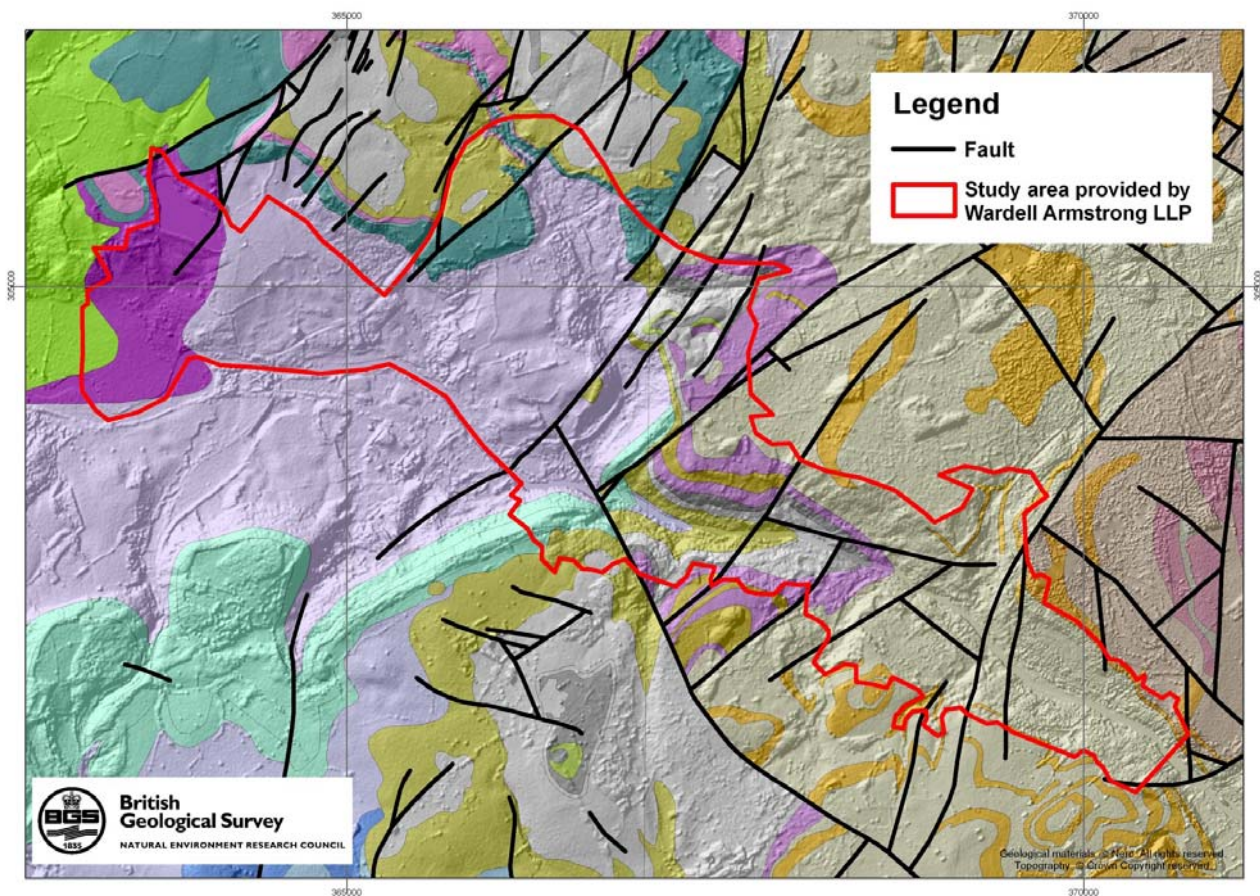
Two distinct fault orientations are identified (Figure 4; Figure 8). North-east-trending faults dominate but subordinate east-south-east orientated structures are also important, particularly in the Lloyd's Coppice area.

There are no details of the un-named cross-fault which crops beneath the Lloyd's Coppice. This fault is poorly known but a throw of 30 m down to the south has been conjectured (confidential information held within the BGS archive). The brief walkover undertaken at Lloyd's Coppice in 2003 as part of this work indicated additional faulting along a north-east trend. The evidence was found in the upper slopes of the Coppice where the Thick Sandstone appears to be downfaulted in a small graben structure. The graben was clearly seen in the upper face of the Coppice, and was considered to be infilled with Glacial Till; it was not known how persistent this structure was (Dr Andrew Gibson pers. comm.). If the interpretation is correct, this structure has important implications on the stability of the Gorge because of its potential influence on groundwater flow. At the time of this survey, in 2003, water was seen flowing as a stream from the base of the downfaulted sandstone block close to its western end and this is presumably having an impact on the stability of the lower slopes.

Figure 8 Extract from BGS 1:50, 000 scale digital geology map showing faults superimposed on NextMap™ topographic model. Refer to Figure 3 for bedrock geology.

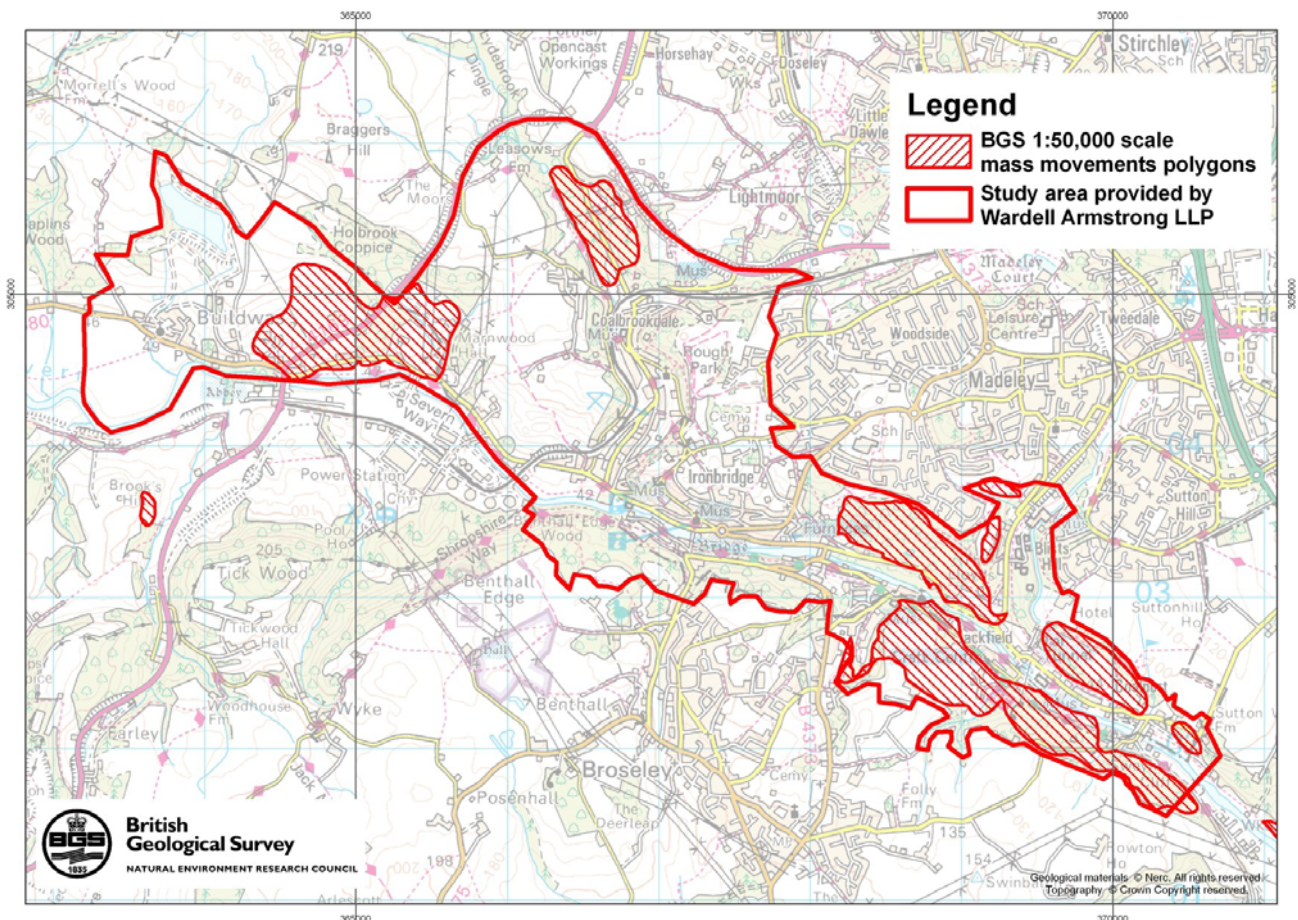
Ironbridge Gorge has experienced a number of failures in historical times. Landslides affect both sides of the Gorge, and some extend into the deeply incised tributary valleys. Unstable or potentially unstable slope deposits extend along the length of the Gorge and the mapped distribution (Figure 9) is a conservative estimate (Bridge and Hough, 2002). As described above, the main valley is thought to have been created relatively rapidly, meaning that the slopes have not yet been able to adopt a stable angle. The valley has also been subject to periglaciation (Hamblin and Coppack, 1995). Characteristic of this would have been seasonal freeze-thaw producing ice-heave, fracturing of the ground and pervasive solifluction and raised groundwater conditions (Rayner *et al.*, 2007).

Figure 9 Extent of mapped mass movement polygons from 1:50,000 scale digital mass movement map (DiGMapGB-50)

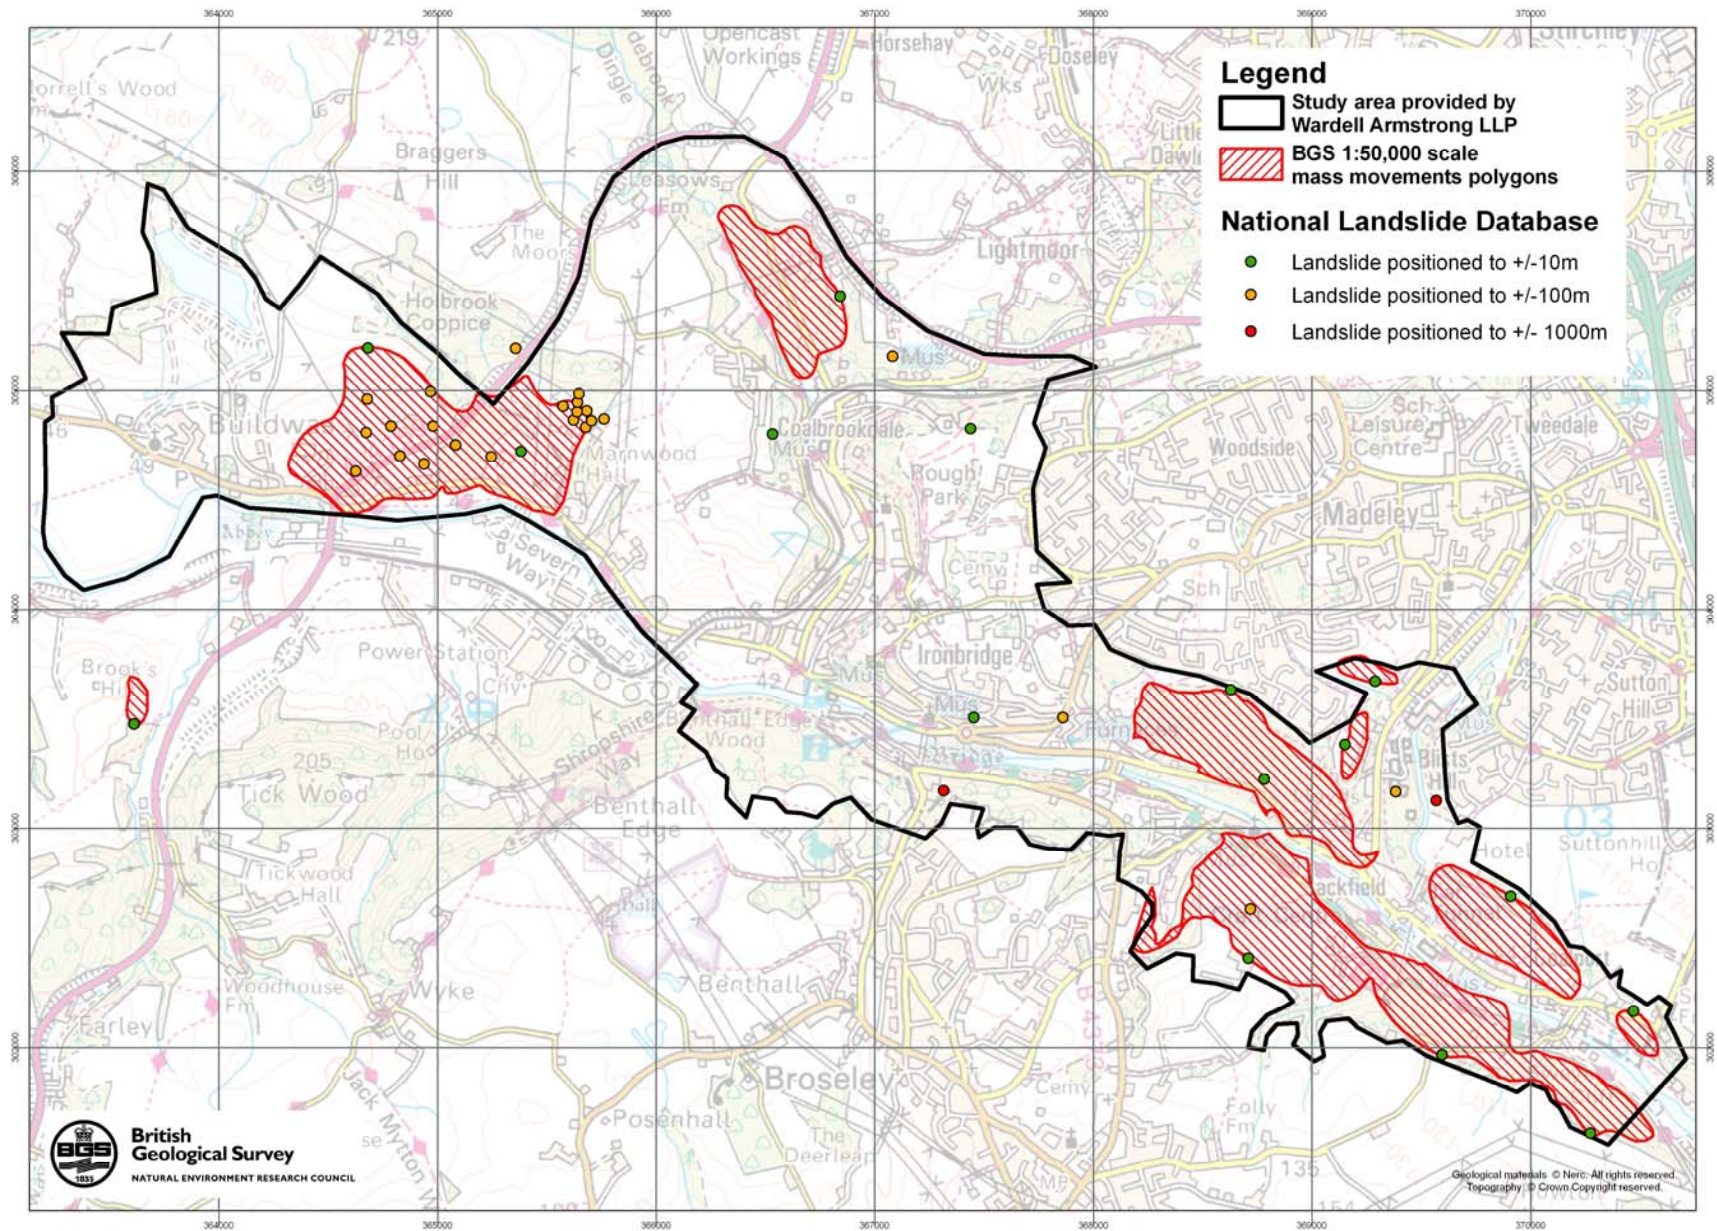
The landslides held within the National Landslide Database for the study area are listed in Table 2. Figure 10 shows their distribution. These will be dealt with individually and the National Landslide Database Identification (NLDID) numbers included in the description.

Figure 10 Location of landslides within the National Landslide Database displayed together with the 1:50,000 scale mass movement polygons
